Technical Bulletin: 103113

### **SRV (Sealed Rotary Valve) Disassembly Instructions:**

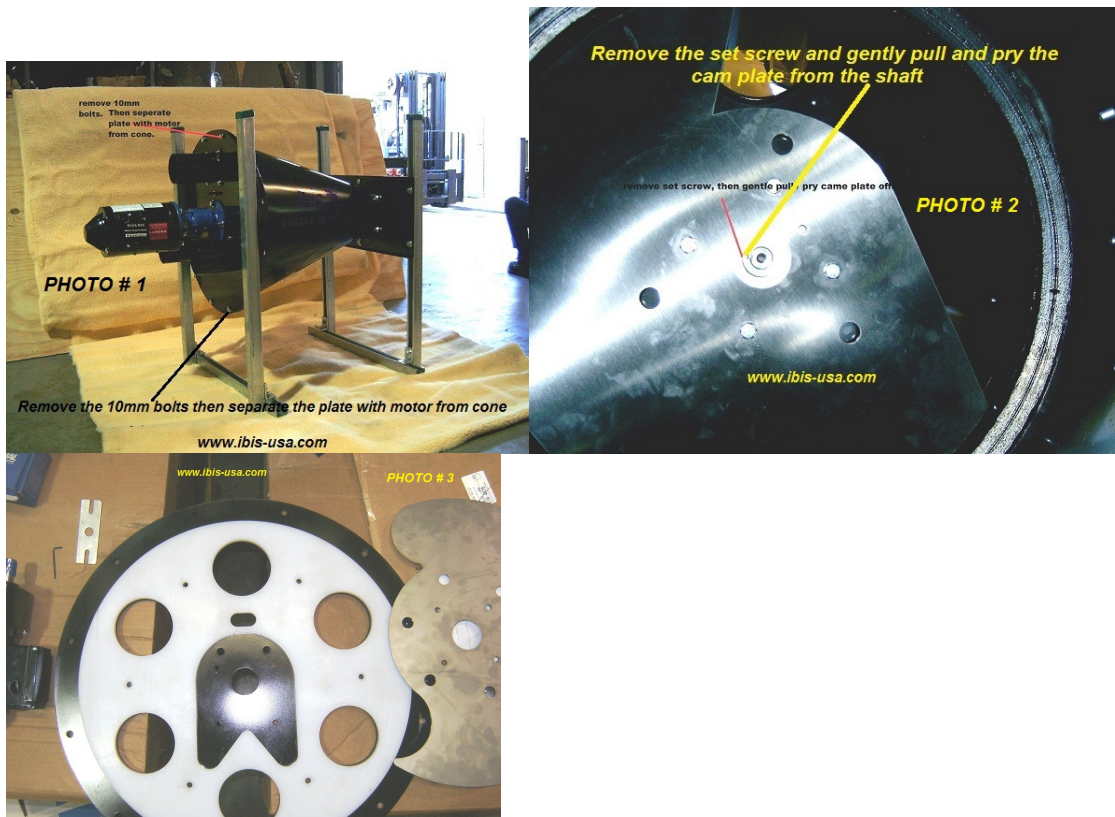
Attached are photos of an SRV. Each photo is noted as to what will be required in order to remove the cam plate inside and have all multiple (5) taps working at the same time. Below are instructions as well.

Remove the 10mm bolts holding the back plate to the cone. There will be silicone between the two so you will have to cut / pry the pieces apart. (photo 1)

Do not remove the damaged motor. Lay the back plate with motor down and you will see the silver cam plate. There is a set screw holding this to the motor shaft. Loosen it and then gentle pull or pry the plate off. This will open up all ports for cleaning all nozzles at the same time. (photo 2)

Photo 3 shows what you should see once parts are removed. You can now reassemble the back plate with motor to the cone. This will allow continuous cleaning on all nozzles at the same time.
